**PROPERTY CONDITION ASSESSMENT
OF
WORLD TRADE CENTER PORTFOLIO**

ONE WORLD TRADE CENTER

Merritt & Harris, Inc. Project Number 20-251E

Re: Due Diligence Physical Condition Survey
World Trade Center
New York, New York

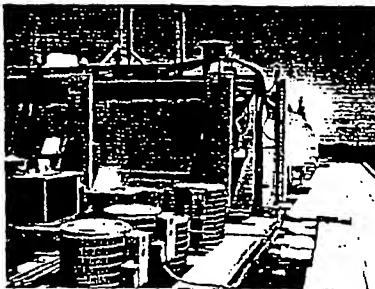
Antennas in Close Proximity to Air Conditioning Equipment Could Lead to Unnecessary Exposure

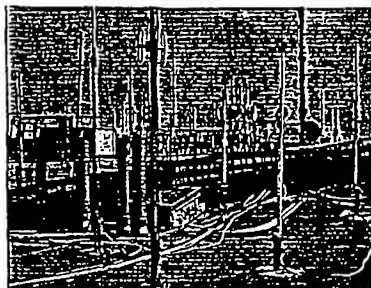
Antenna mounting density at the WTC can make it difficult to get away from strong fields

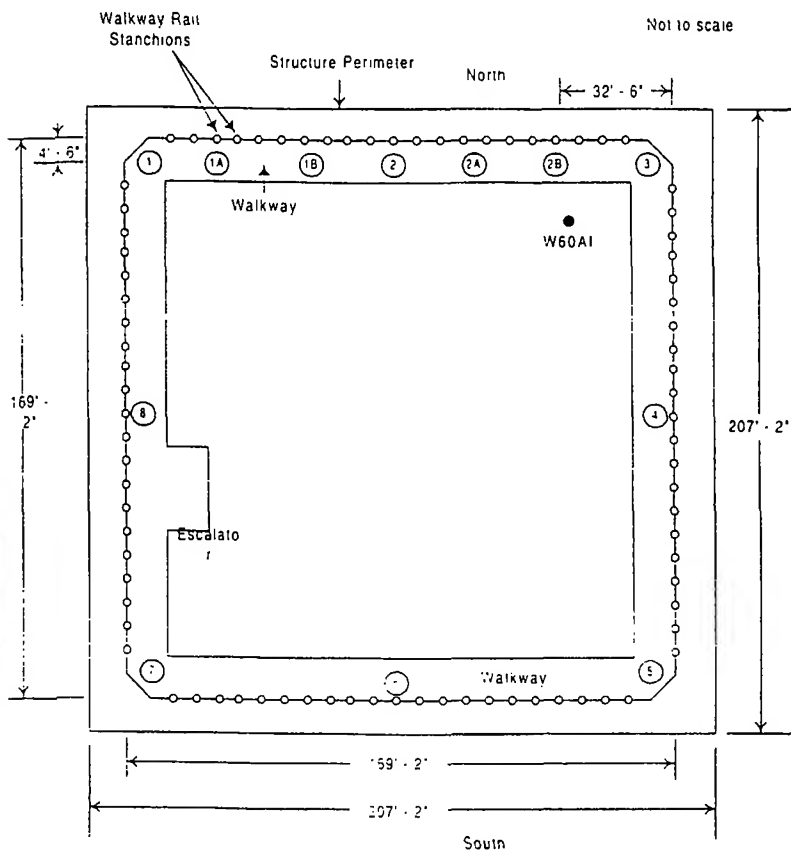
MEASUREMENT LOCATIONS
 WORLD TRADE CENTER
 SOUTH TOWER ROOFTOP OBSERVATION DECK WALKWAY

- Notes: 1. Measurement locations are indicated by circled numbers and letters, e.g. (1A).
 2. Observation deck walkway is approximately 9 feet above building roof level.

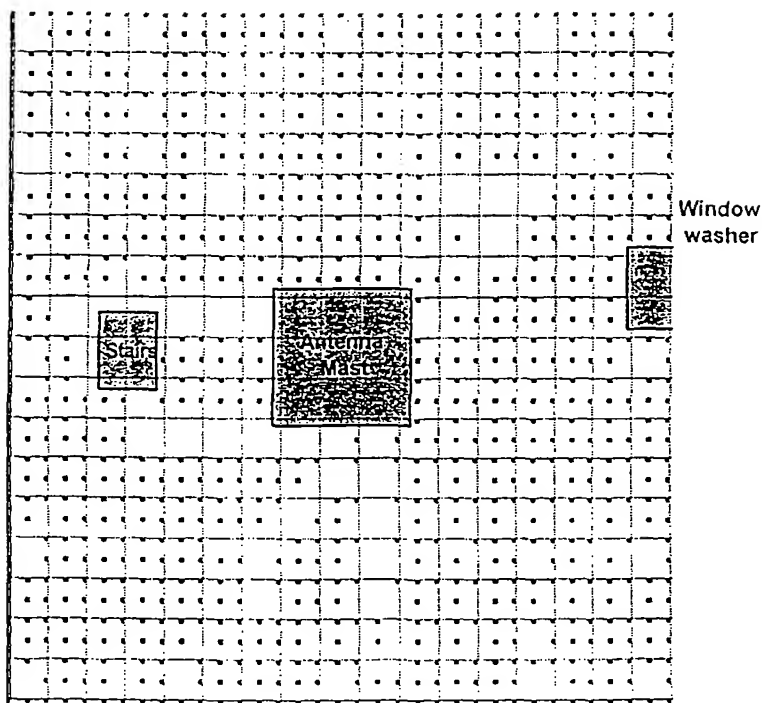
Figure 5. WTC roof map showing the location and distribution of all included 889 measurement points. The overall measurement area was 170 feet by 170 feet with measurement points spaced generally five feet apart except when a point fell within 2.5 feet of an existing roof-mounted antenna or other metallic structure such as cable trays and roof-mounted lights that might perturb the local fields.

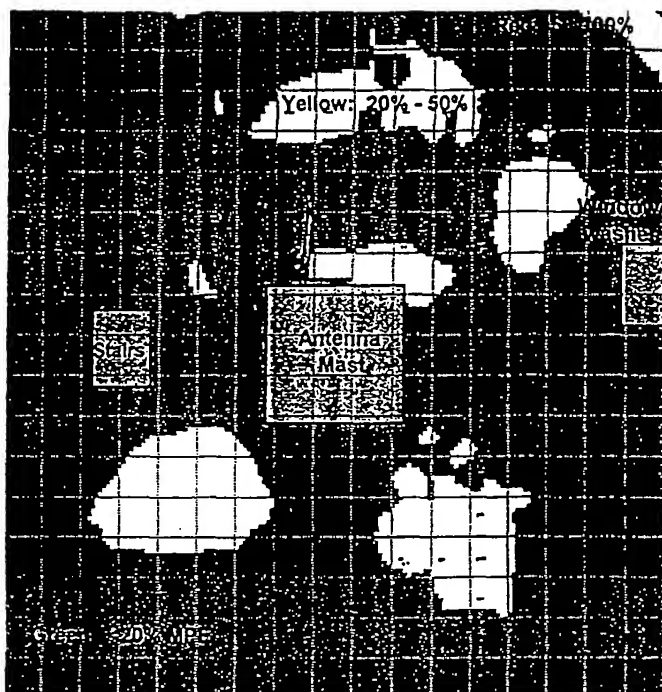
The contribution of the 72 MHz paging link antennas was examined by removing the theoretically calculated fields from those antennas using the RoofView software. This was accomplished by making custom modifications to RoofView which permitted the computation of those fields, as would be performed during a conventional roof analysis, but then subtracting those results for each pixel on the roof. When this process was accomplished, the maximum RF field on the roof was found to decrease from 70.2% (with the 72 MHz pagers included) to 56.6% of the MPE, thereby increasing the amount of roof area subject to fields less than 20% of the MPE. Under this condition, only 15% of the roof area (3,943 square feet) was found to exceed 20% of the MPE. Figure 8 illustrates the resulting colorized roof map of this hypothetical mode of operation.

Figure 8. Roof map of normal broadcast ambient RF fields with contribution of 72 MHz paging links removed via analysis with RoofView. Maximum field is 56.6% MPE.

Statistical summary of RF Fields on WTC roof (see Figure 8)		
Percent occupational MPE range (%)	Roof area in this range (ft ²)	Percent of roof area in this range (%)
0-20	23262	85.51
21-50	3937	14.47
51-100	6	0.02
>100	0	0.00

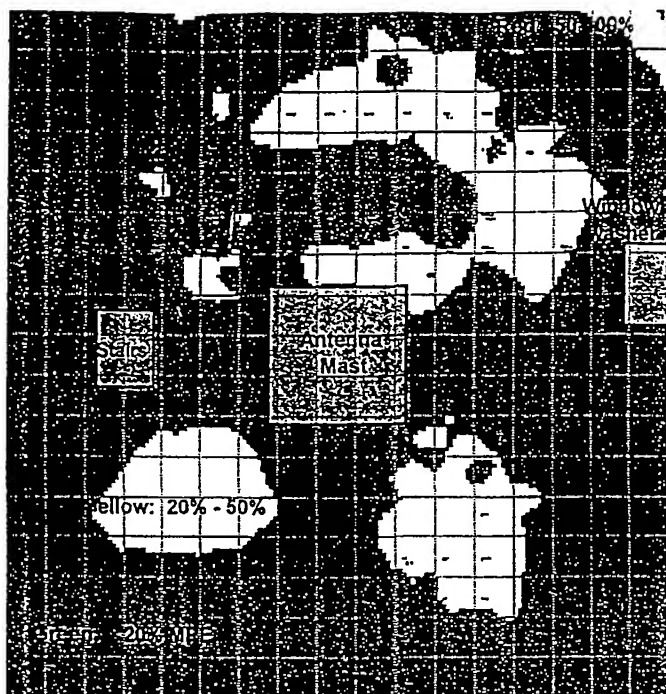
were left as is. The results are shown in Figure 9 and indicate that the maximum RF field level would decrease from 70.2% of the MPE (with the paging links at their present mounting heights) to 57.2% of the MPE. RoofView was first used to subtract the calculated fields from each paging link antenna at each roof pixel, and then to add their contribution back into the ambient, measured broadcast field levels for the condition of being raised to six feet above the roof where applicable.

Figure 9. Roof map of RF fields during normal broadcast operations with calculated effect of raising 72 MHz paging links to 6 feet above roof. No other wireless antennas active. Maximum field is 57.2% MPE.

Statistical summary of RF Fields on WTC roof (see Figure 9)		
Percent occupational MPE range (%)	Roof area in this range (ft ²)	Percent of roof area in this range (%)
0-20	21878	80.42
21-50	5318	19.55
51-100	0	0.03
>100	0	0.00

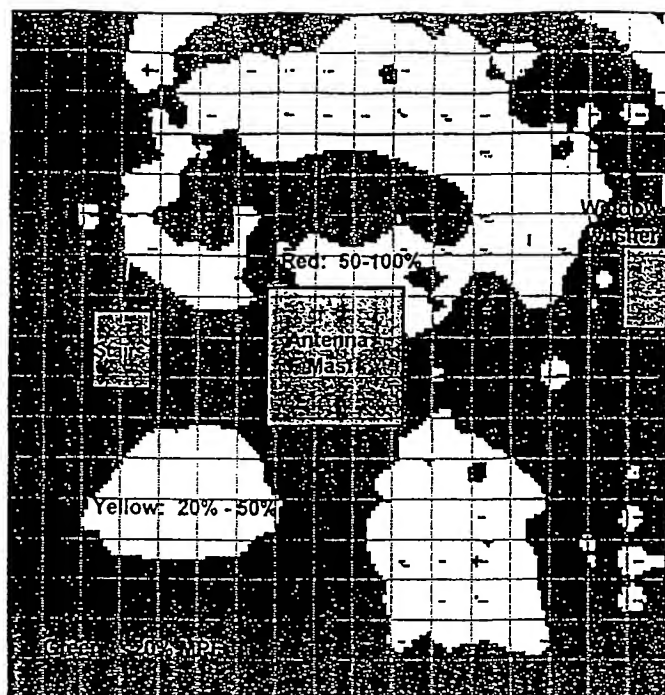
Finally, the result of raising all wireless antennas on the WTC roof to at least six feet was evaluated using RoofView. All antenna mounting heights that were indicated as less than six feet above the roof deck were increased to six feet. Those already mounted greater than six feet above the roof were left as is, similar to the treatment of the 72 MHz paging links discussed above. As expected, this process resulted in significantly lower fields, bringing the projected maximum RF field, found at any place on the roof, down from 314% of the MPE to only 67.2%. Figure 10 illustrates the colorized roof map for this condition. In this case, no area on the roof exceeded 100% of the MPE and the roof area subject to fields greater than the uncontrolled exposure MPE (83.5% before raising the wireless antennas) was reduced to only 32.6%. This substantial reduction in RF field levels supports the common contention that antenna mounting height can play a very significant role in controlling RF fields at roof-top antenna sites.

Figure 10. Roof map of RF fields during normal broadcasting operations with calculated effect of raising all wireless antennas to 6 feet above roof level. Maximum field is 67.2% MPE

Statistical summary of RF Fields on WTC roof (see Figure 10)		
Percent occupational MPE range (%)	Roof area in this range (ft ²)	Percent of roof area in this range (%)
0-20	18325	67.36
21-50	8794	32.32
51-100	86	0.32
>100	0	0.00

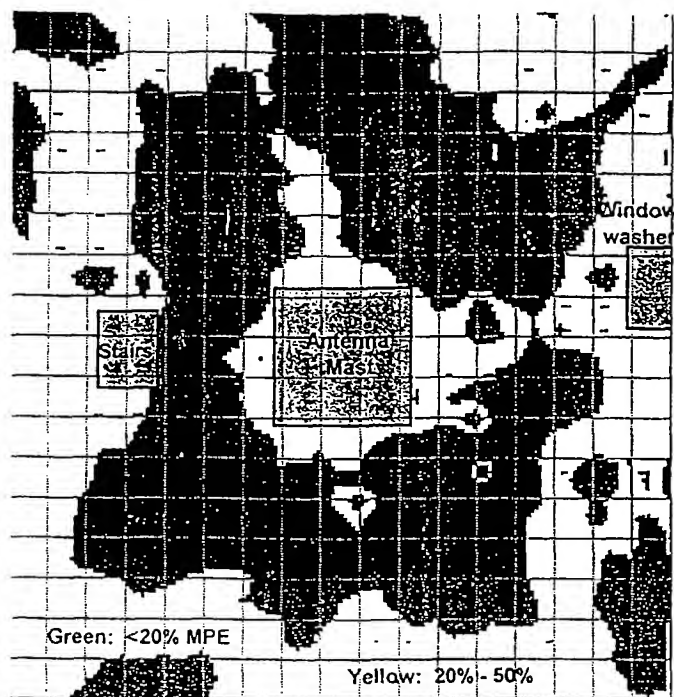
If the contribution of the 72 MHz paging links is removed, in a fashion like that described above, the resulting roof map, shown in Figure 13, shows that the maximum RF field level has been reduced from 147% of the MPE to 138% and the extent of the roof area that is subject to fields exceeding the lower, general public MPE is slightly decreased to 94.3% of the roof surface. This condition projects the expected ambient RF field levels

Figure 13. Roof map of RF fields during tower maintenance mode with contribution of 72 MHz paging links removed with RoofView. Maximum field is 138.3% MPE.

Statistical summary of RF Fields on WTC roof (see Figure 13)		
Percent occupational MPE range (%)	Roof area in this range (ft ²)	Percent of roof area in this range (%)
0-20	1546	5.68
21-50	13108	48.18
51-100	12035	44.24
>100	516	1.90

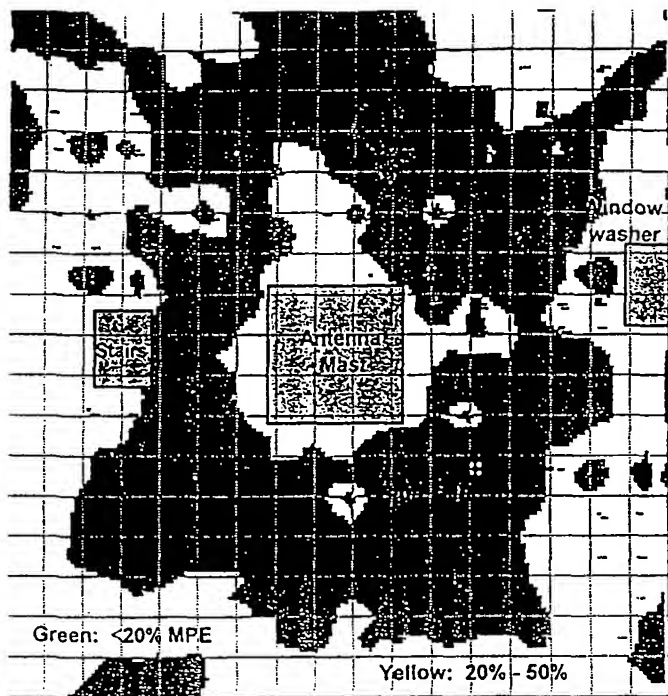
The RF field mitigation effects of elevating the many wireless antennas to at least six feet above the roof surface is illustrated in Figure 14. In this case, wireless antennas not already mounted at least six feet above the roof were elevated in mounting height through use of the RoofView software. When this was done, the maximum RF field on the roof was found to be 144% of the MPE compared to 352% before raising the antennas and the amount of roof area subject to fields exceeding 100% of the MPE now represents only 2.55% of the roof area. However, 96.4% of the roof area is still at RF levels exceeding the general public MPE.

Figure 14. Roof map showing RF fields during broadcast tower maintenance mode with calculated effect of all wireless antennas raised to at least 6 feet above roof
Maximum field is 144.3% MPE

Statistical summary of RF Fields on WTC roof (see Figure 14)		
Percent occupational MPE range (%)	Roof area in this range (ft ²)	Percent of roof area in this range (%)
0-20	992	3.65
21-50	12641	46.47
51-100	12879	47.34
>100	693	2.55

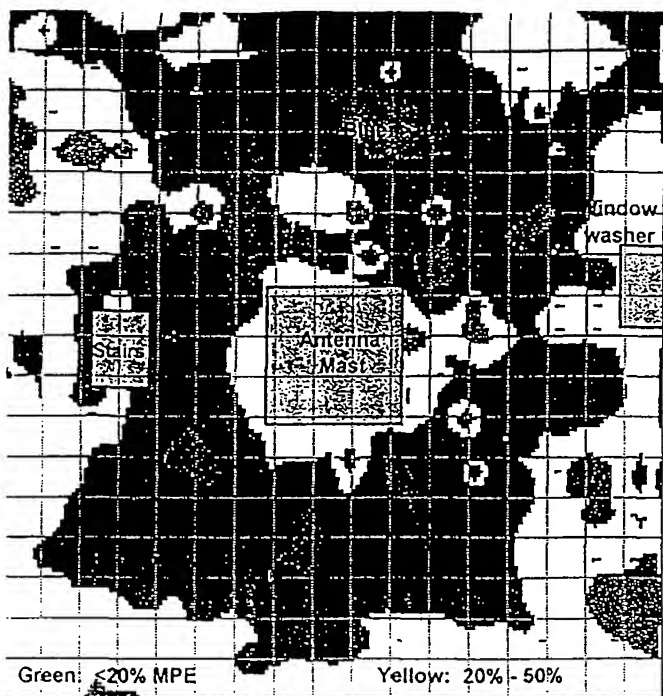
Figure 17. Roof map of emergency backup broadcast ambient RF fields with contribution of 72 MHz paging links removed via analysis with RoofView. Maximum field is 135.2% MPE.

Statistical summary of RF Fields on WTC roof (see Figure 17)		
Percent occupational MPE range (%)	Roof area in this range (ft ²)	Percent of roof area in this range (%)
0-20	1135	4.17
21-50	11034	40.56
51-100	14148	52.01
>100	888	3.26

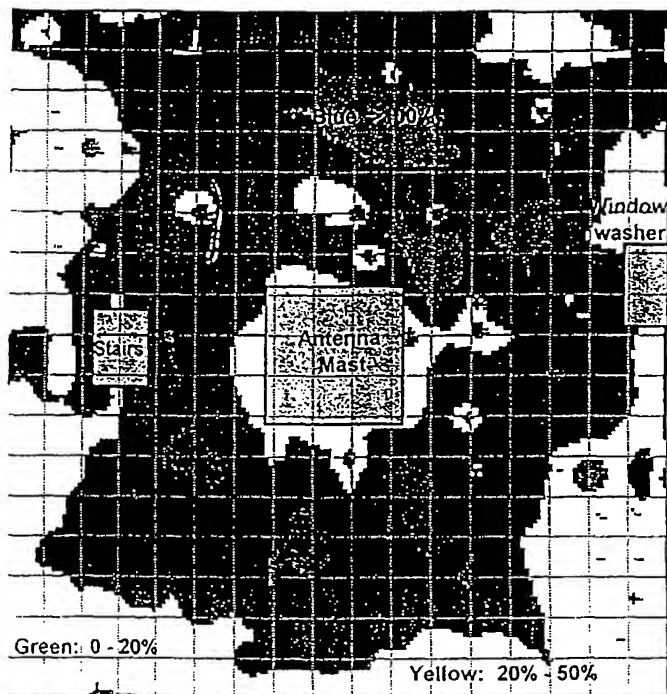
Figure 18. Roof map of RF fields during emergency broadcast backup operations with calculated effect of all wireless antennas raised at least 6 feet above roof level. Maximum field is 149.3% MPE.

Statistical summary of RF Fields on WTC roof (see Figure 18)		
Percent occupational MPE range (%)	Roof area in this range (ft ²)	Percent of roof area in this range (%)
0-20	249	0.92
21-50	9104	33.46
51-100	16151	59.37
>100	1701	6.25

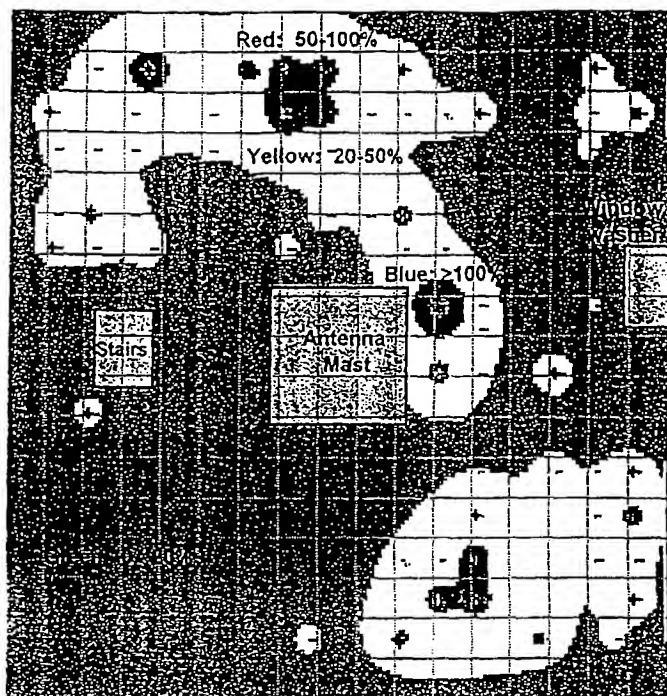
Figure 19. RoofView computed roof map for all wireless telecommunications antennas assumed operating but without contribution of RF fields from any of 72 MHz paging links or any contribution from broadcasting facilities. Maximum field is 273 9% MPE.

Statistical summary of RF Fields on WTC roof (see Figure 19)		
Percent occupational MPE range (%)	Roof area in this range (ft ²)	Percent of roof area in this range (%)
0-20	17324	63.68
21-50	8960	32.94
51-100	833	3.06
>100	88	0.32

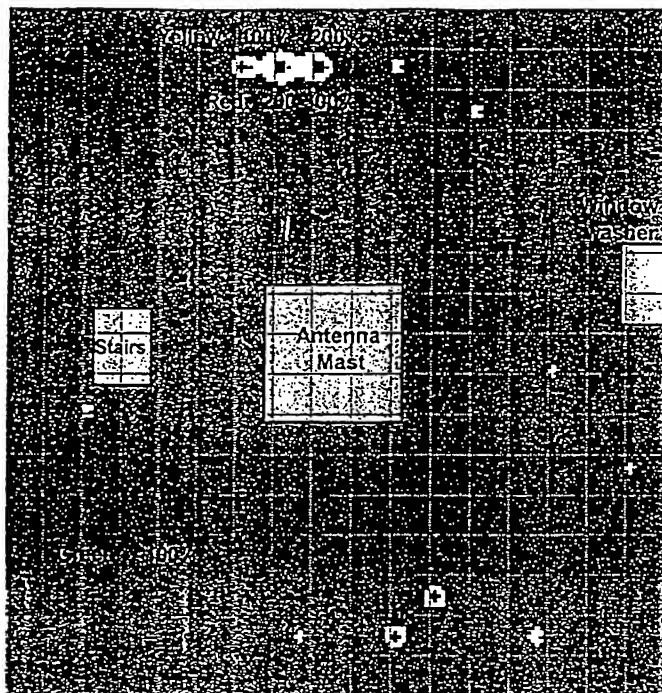
Figure 20. Roof map of calculated spatial peak RF fields from all wireless antennas only operating above 800 MHz. Maximum peak field is 276% MPE.

Statistical summary of RF Fields on WTC roof (see Figure 20)		
Percent occupational MPE range (%)	Roof area in this range (ft ²)	Percent of roof area in this range (%)
0-100	26956	99.08
101-200	216	0.79
201-300	33	0.12
>300	0	0.00

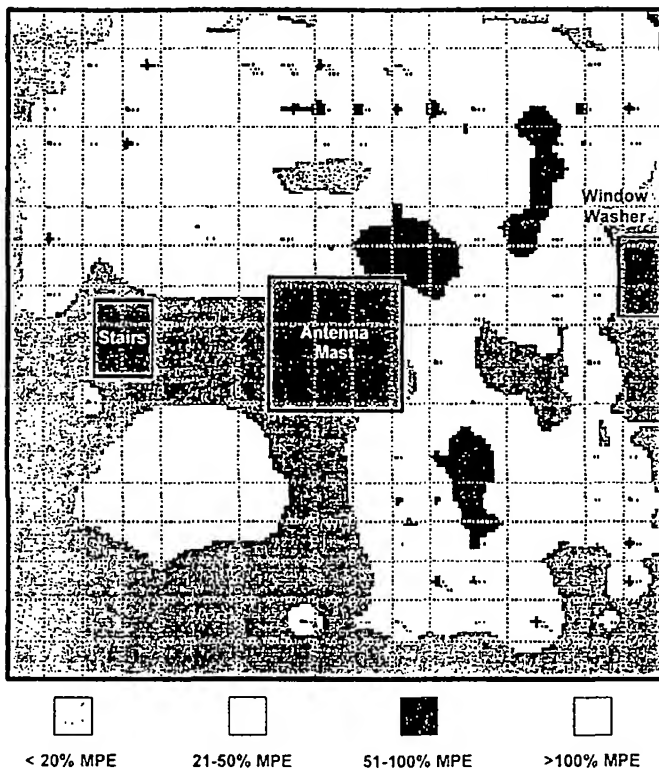
Figure 2. 1999 reevaluation of RF fields from measured ambient fields of normal broadcasting operations with calculated contribution of all wireless telecommunications antennas with selected antennas raised to eliminate fields exceeding MPE. Maximum field is 77.5% MPE.

1999 Statistical summary of RF Fields on WTC roof		
Percent occupational MPE range (%)	Roof area in this range (ft ²)	Percent of roof area in this range (%)
0-20	9810	36.06
21-50	16232	59.67
51-100	1163	4.27
>100	0	0.00

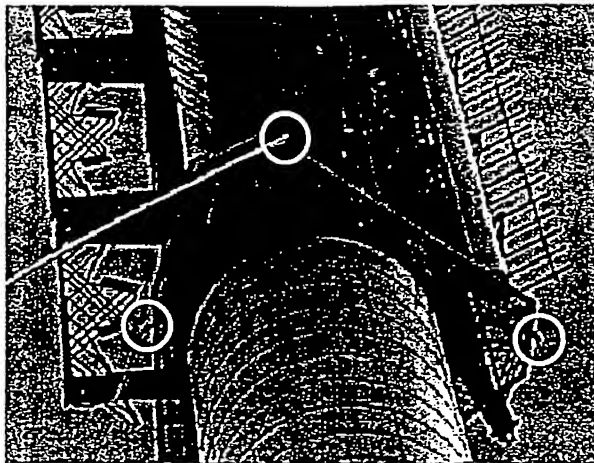
Figure 2. Close up photo showing attachment of nylon ropes at ice shield at top of the channel 47 antenna aperture. Pulleys allow the ropes to be pulled to elevate the electric field probe. A fourth pulley, on the opposite side of the mast, cannot be seen in this view.
